Sutton-Kennerly & Associates, Inc.
530 Hendersonville Road
Asheville, NC 28803-2826

ASHEVILLE CITY HALL
WATER INTRUSION INVESTIGATION
FINAL REPORT

February 16, 2010

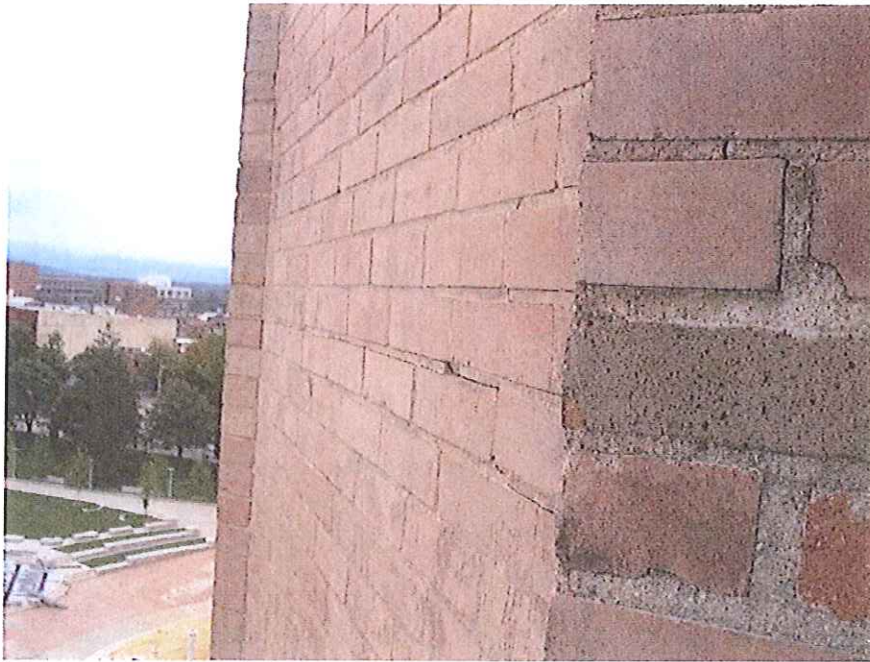
43. A view of the southwest corner of the building where the brick is mitered at a 45° angle. The mortar is cracked and some of it is missing from the brick bed joint at the shelf angle location.

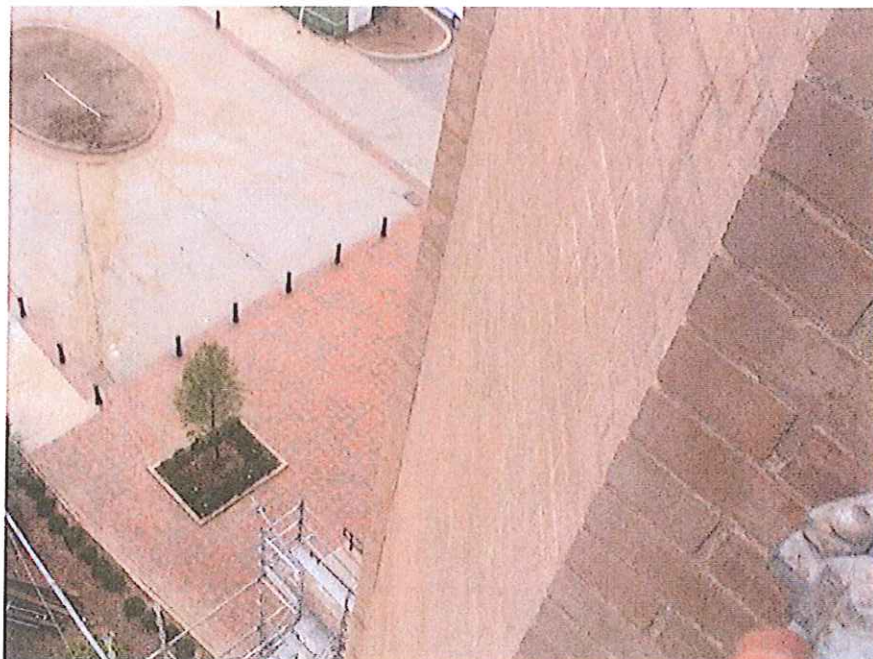
44. There is a vertical crack in the brick where the southwest mitered corner meets the brick on the west wall of the building.

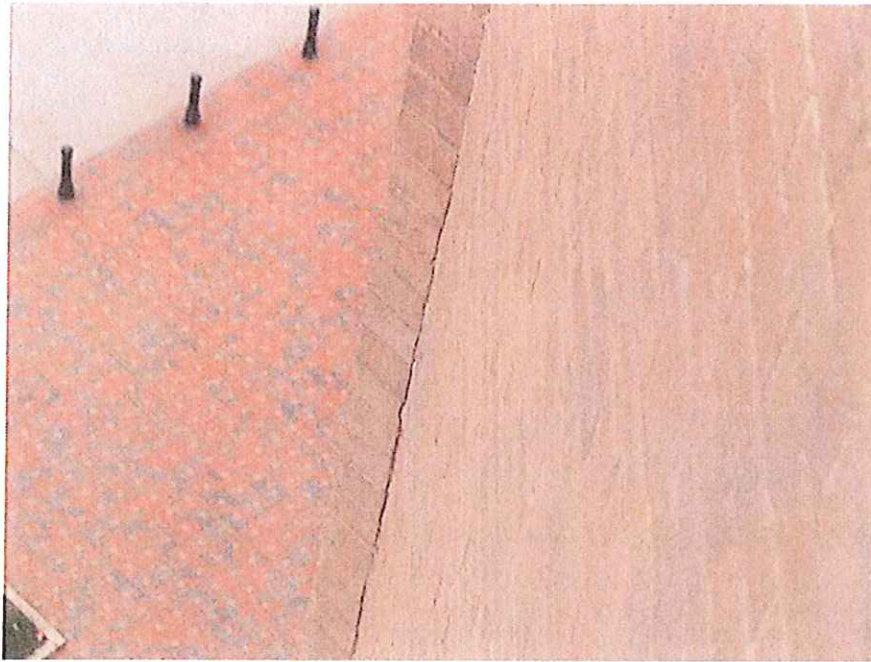
45. A closer view of the crack seen in photo 44. There are no vertical brick expansion joints to allow differential horizontal movement in the brick on the building.

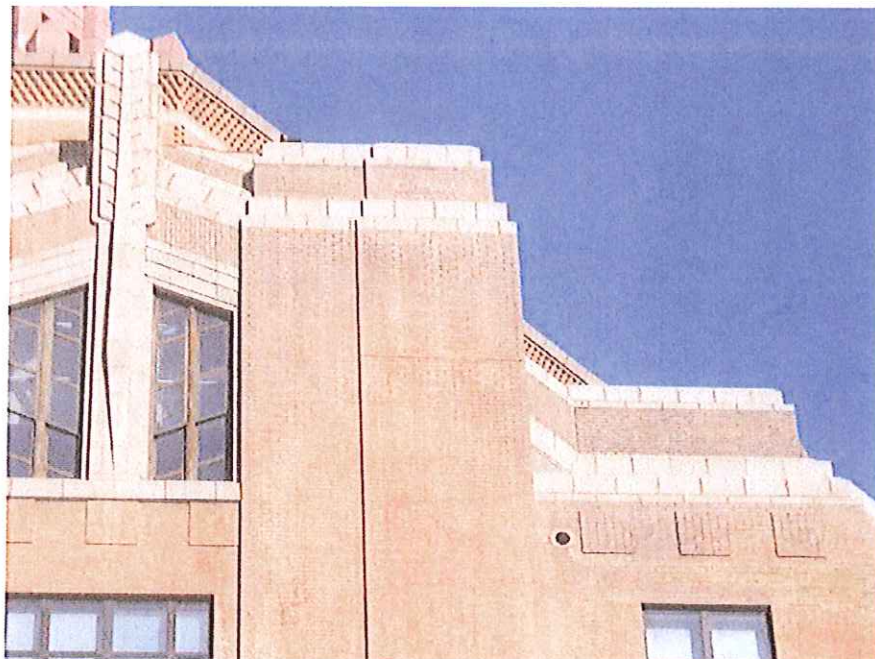
46. Horizontal cracks in the brick at the shelf angle locations on the west face of the building.

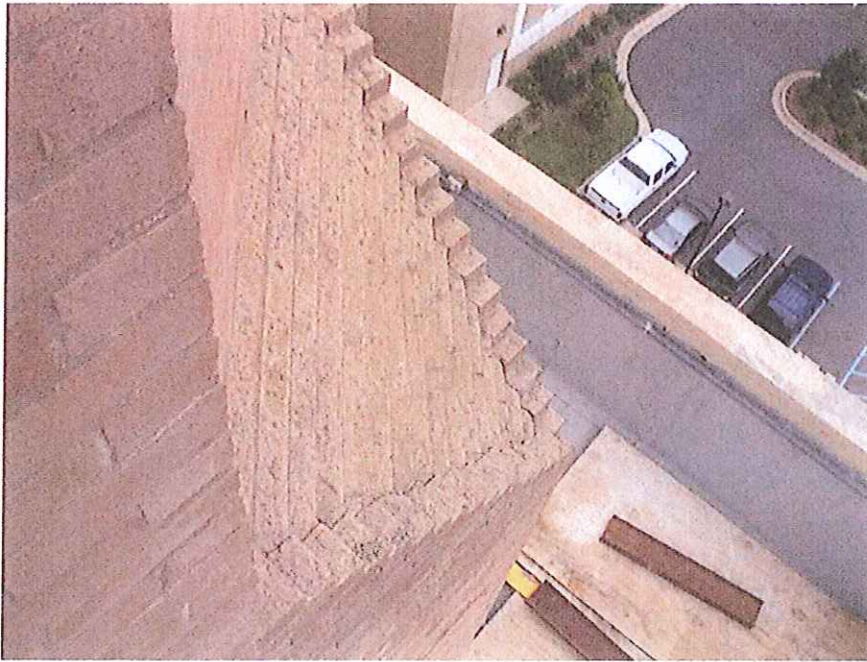
47. The top of the brick buttress at the southeast corner of the building. The brick steps down away from the building at these buttresses, and there is a crack between the brick at the vertical sides of the buttress and the stepped brick on top.

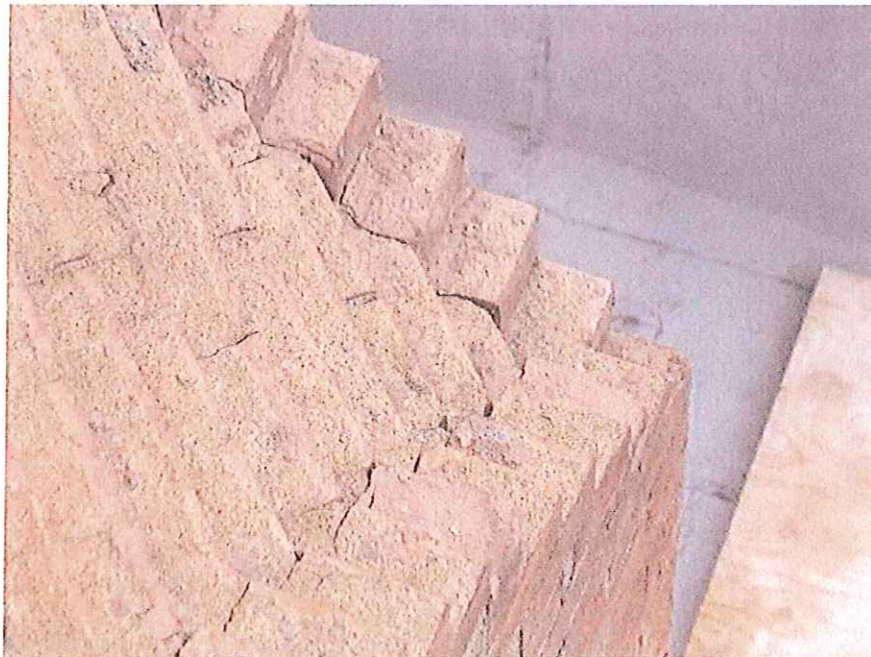
48. A closer view of the crack in the brick at the top of the buttress shown in photo 47. A significant amount of water can enter the brick at these locations which are typical at all four corners of the building.

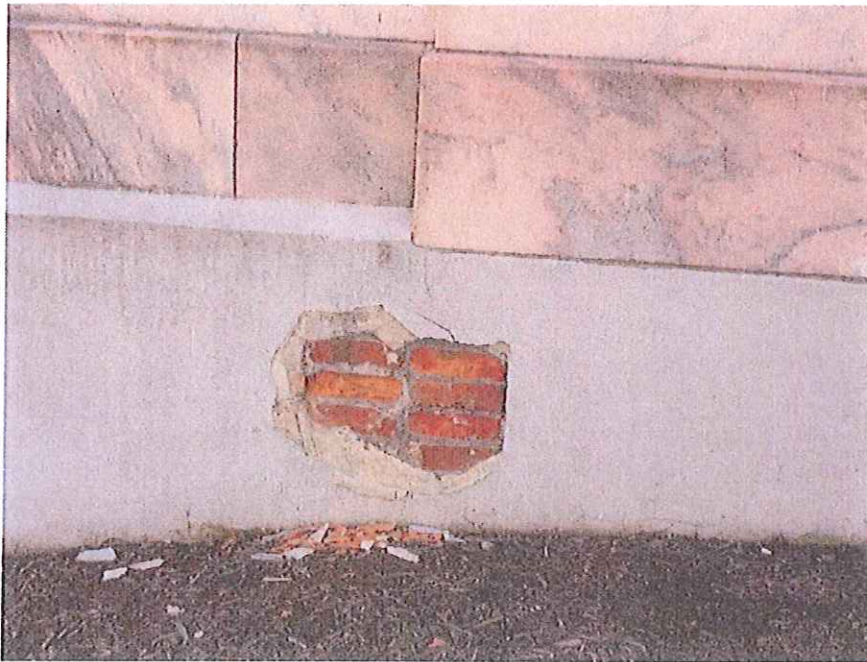
49. An area of brick at the base of the building at ground floor level where the brick is covered with a cement plaster. The plaster and the brick are spalling at this location due to freezing water trapped behind the plaster.

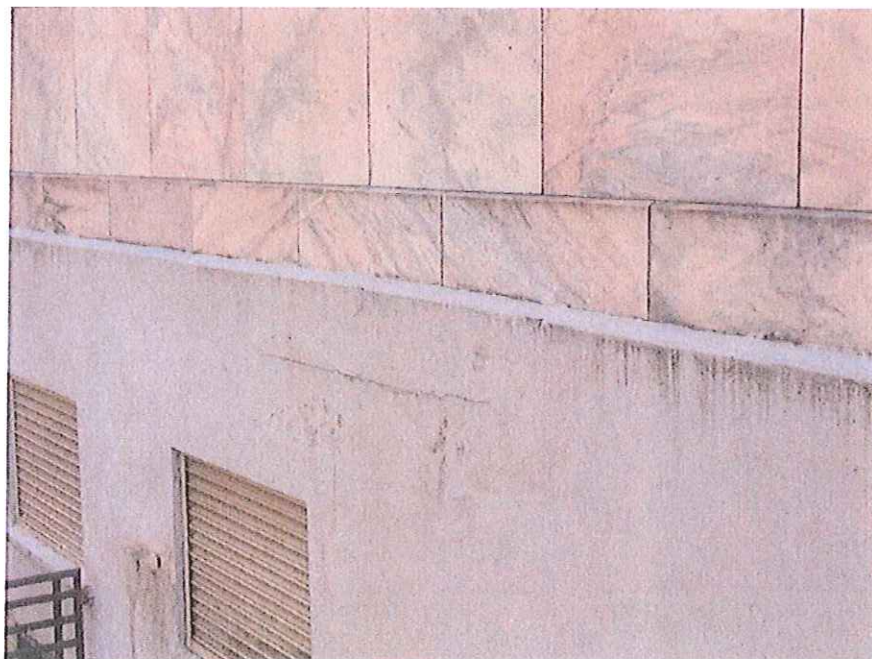
50. Another area in the plaster over the brick at the ground floor level where the plaster is failing. Eventually, this area will spall away similar to the condition seen in photo 49.

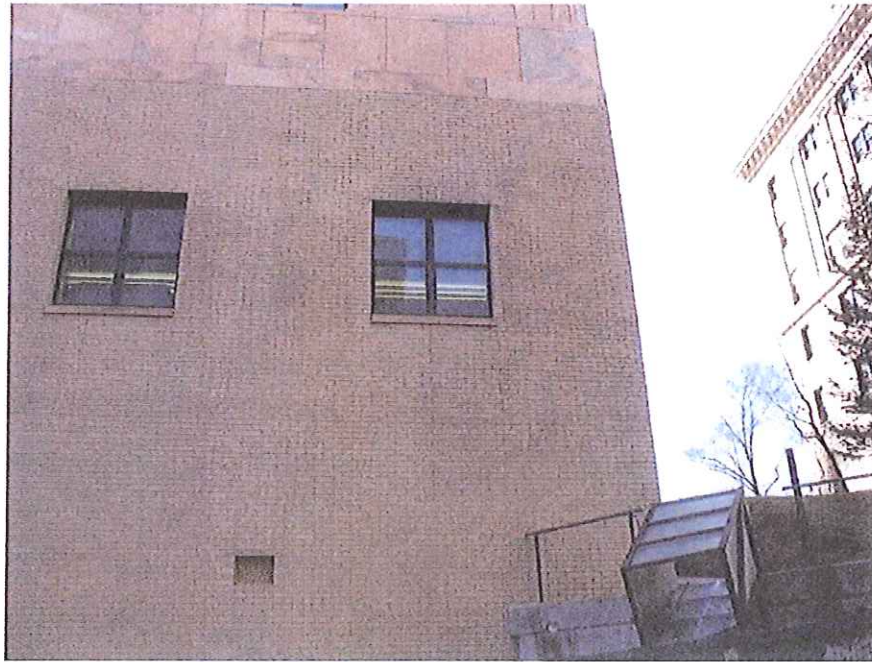
51. Cracks in the brick veneer on the east wall of the building below the ground floor level.

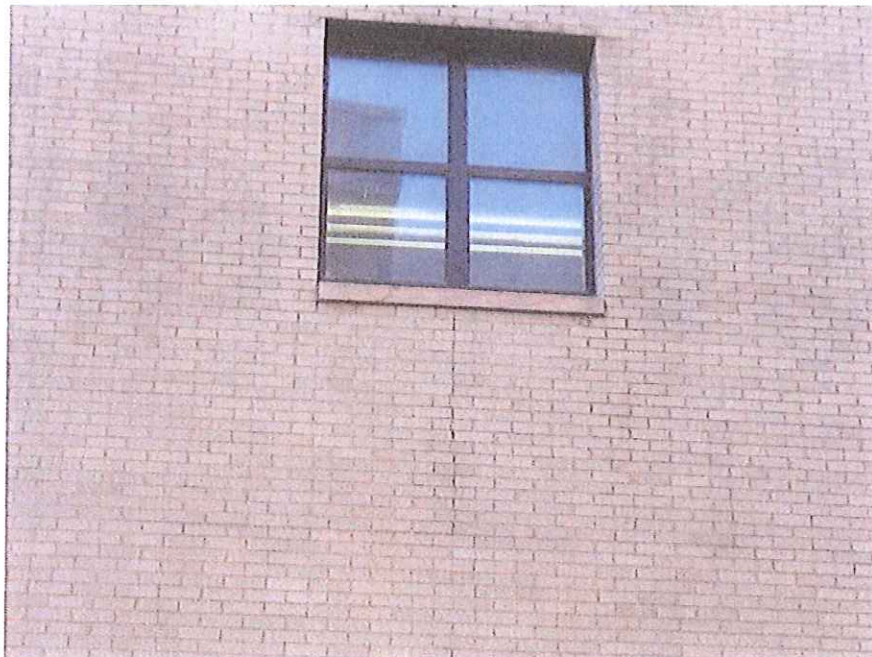
52. A closer view of the cracked brick veneer seen in photo 51.

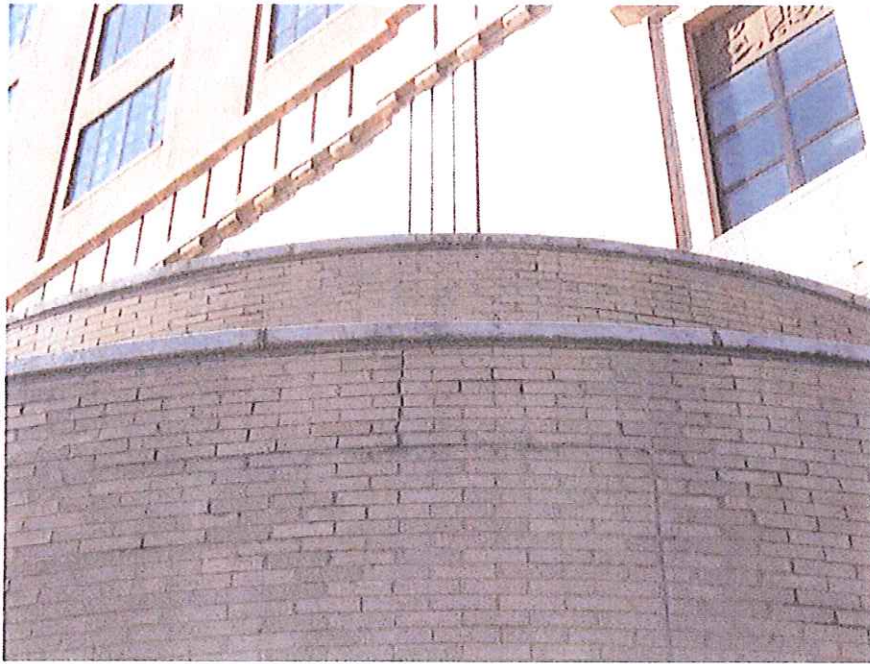
53. Cracks in the circular brick wall at the vehicle ramp at the southeast corner of the building.

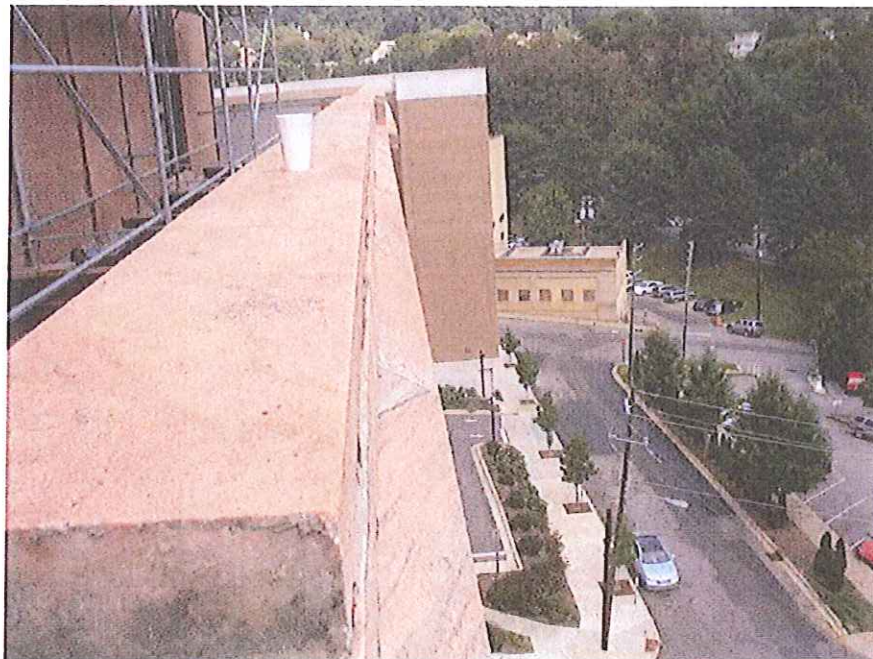
54. The top of the parapet at the second floor level on the south side of the building. It is not readily visible from the photo, but the lower portion of the marble is bowing away from the building along this wall.

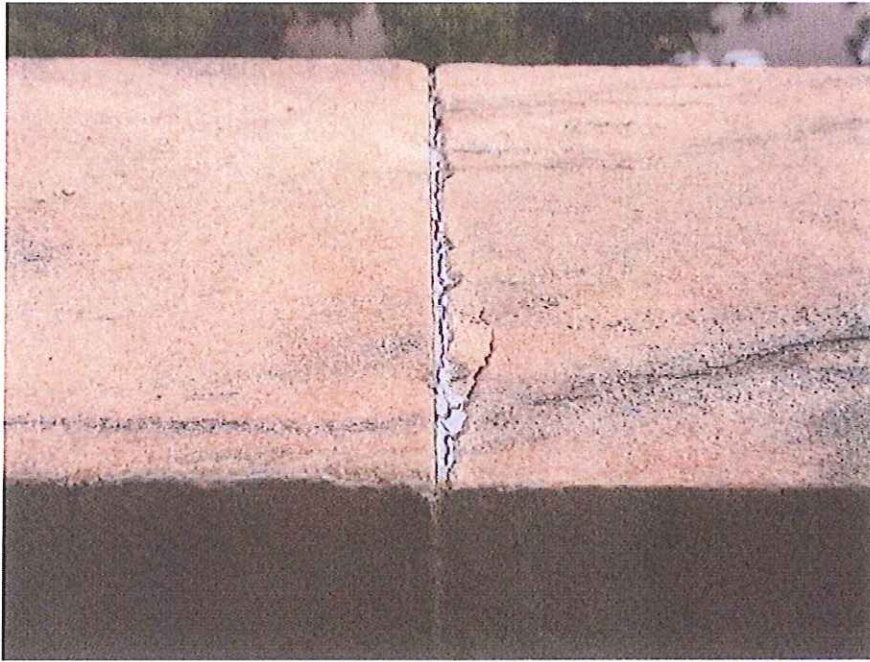
55. A typical joint between the marble coping stones on the second floor parapet. The sealants in the joints have failed, and the marble is beginning to spall at this location.

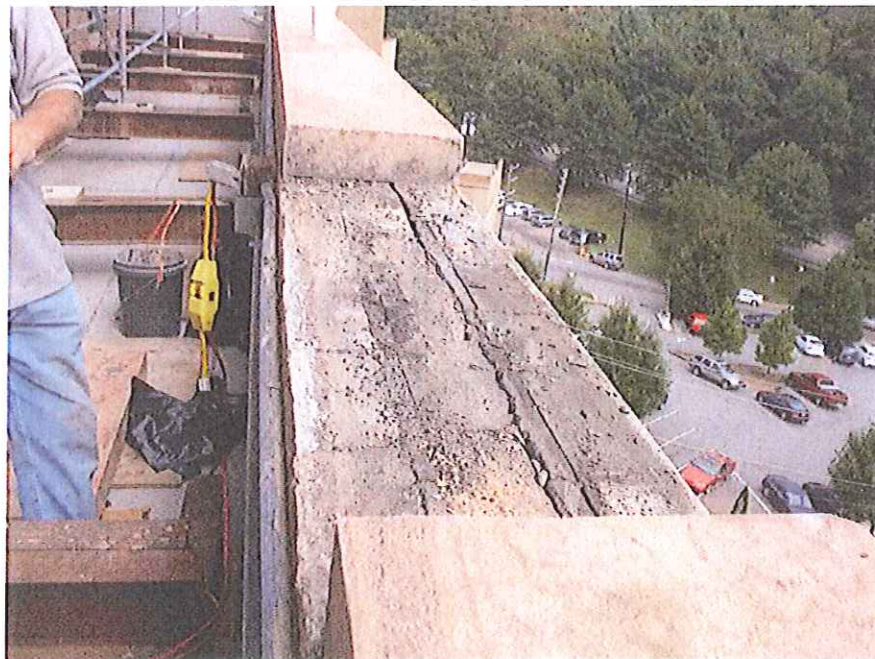
56. A section of the marble coping was removed from the top of the second floor parapet on the south side of the building. There is no flashing below the marble coping. Note the separation of the outer wythe of marble below the coping. It is estimated that the outer wythe of marble has moved outward approximately $\frac{1}{2}$ " at this location.

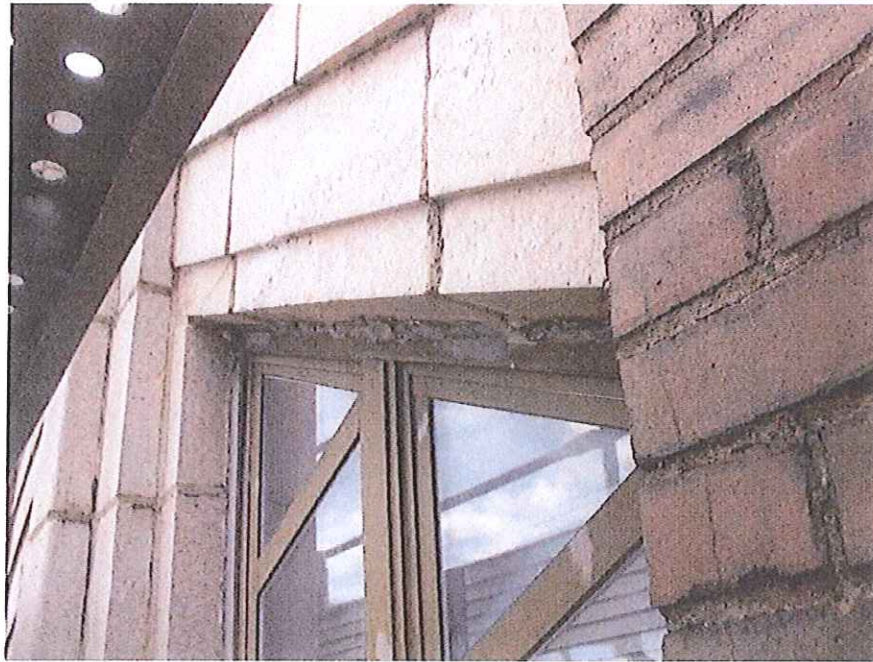
57. The typical condition of the sealants around the trapezoidal windows at the eighth floor level. The sealants between the window frame and the terra cotta have failed completely.

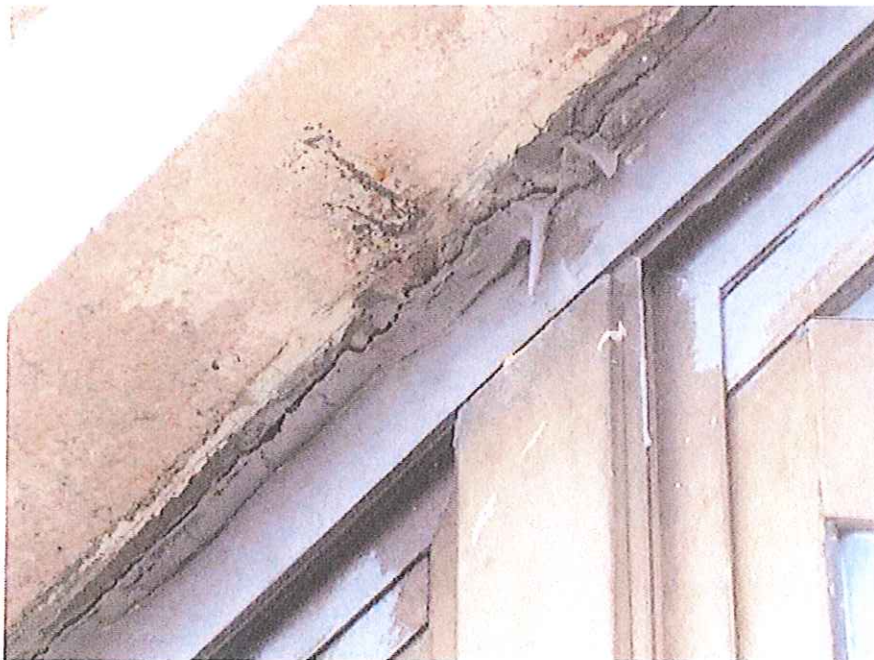
58. A closer view of the failed sealants between the terra cotta and the frames of the trapezoidal windows.

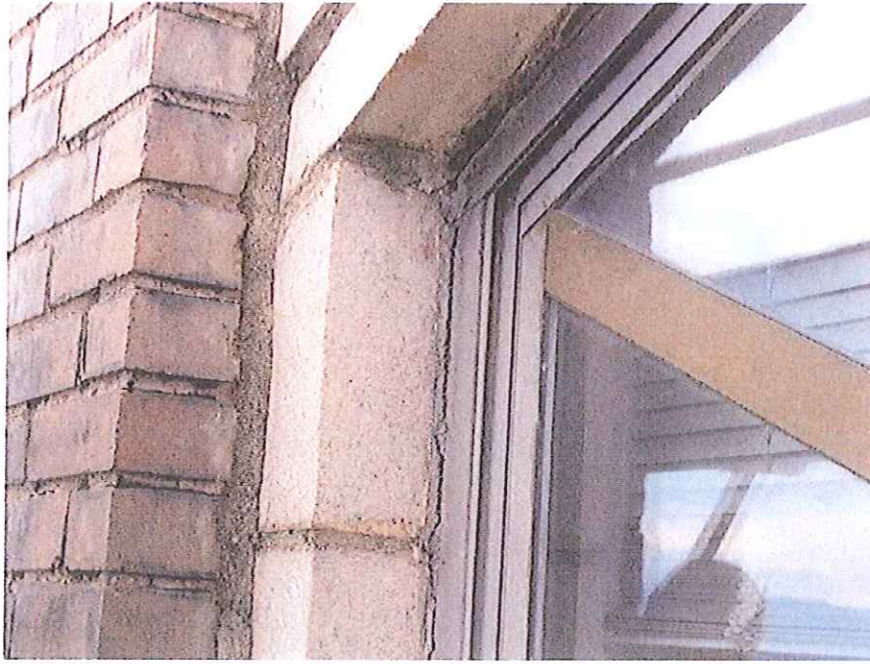
59. Failed sealants at the jambs of the trapezoidal windows at the eighth floor level.

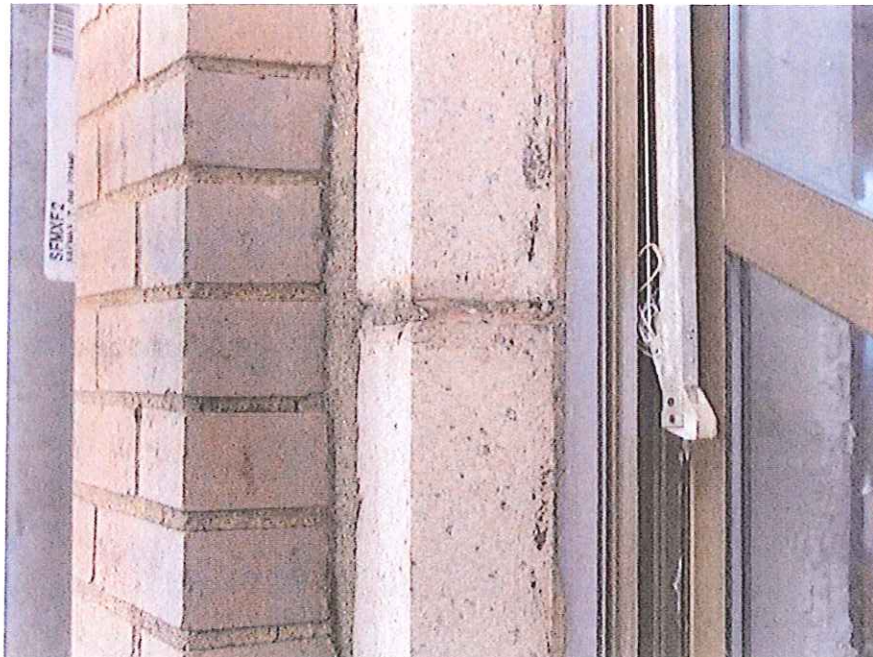
60. The window operating mechanisms of the trapezoidal windows has failed. This condition was noted on the north and south sides of the building. Deterioration of the mortar in the terra cotta jambs is also seen in this photo.

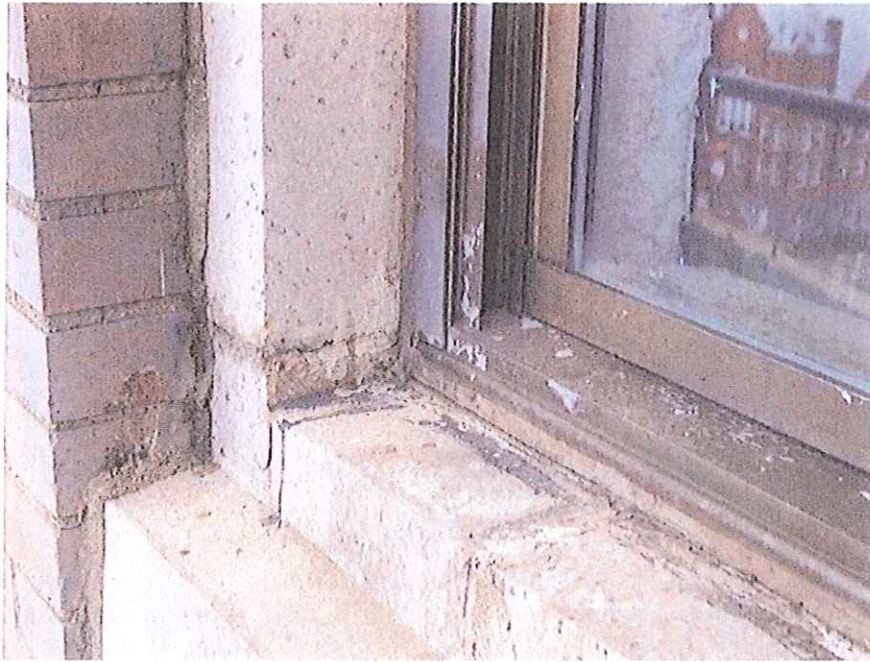
61. A view of the sealant joints at the bottom of the trapezoidal windows. The sealants have all failed allowing water to enter the building.

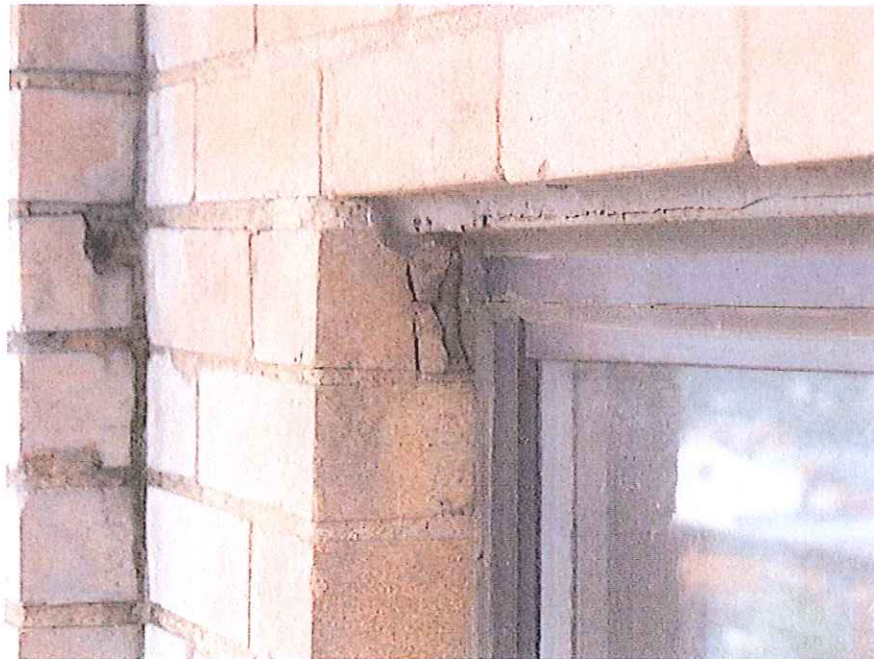
62. A sealant installed over the face of the mortar joint between the brick and the shelf angle above a rectangular window on the south wall of the building. Placing a sealant joint over the face of the shelf angle traps any water that enters the wall above the window.

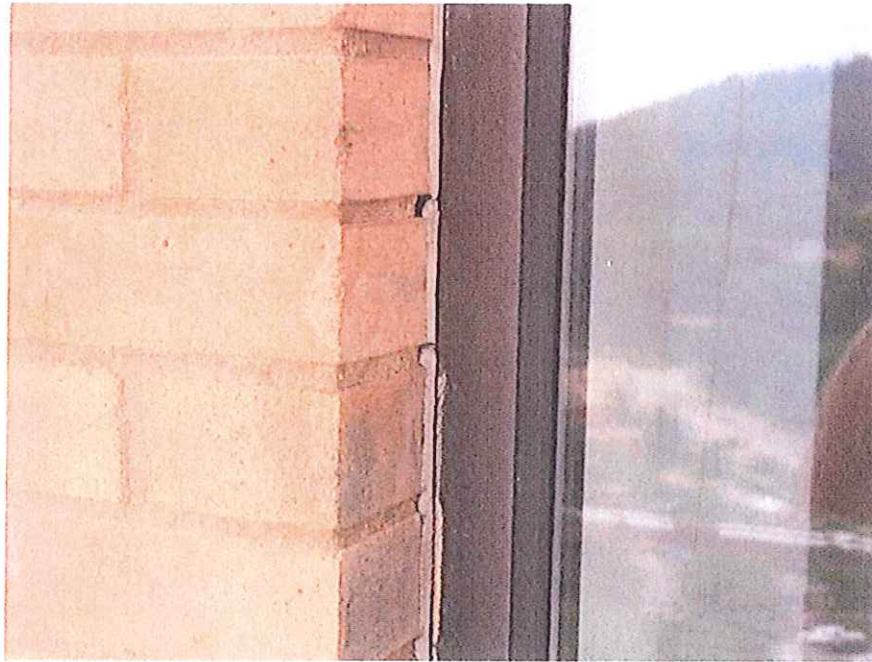
63. The sealants around all of the windows on the building have typically failed.

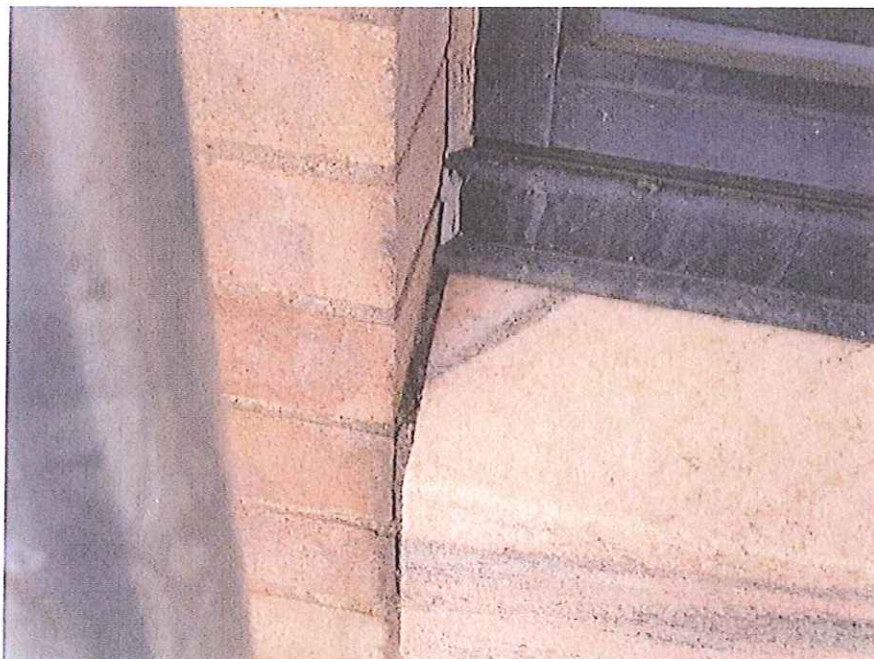
64. The sealants at the marble window sills have failed where they exists typically. At many locations such as this one, there is no sealant. The mortar joint between the brick and the marble sill is typically cracked, allowing water to enter the building.

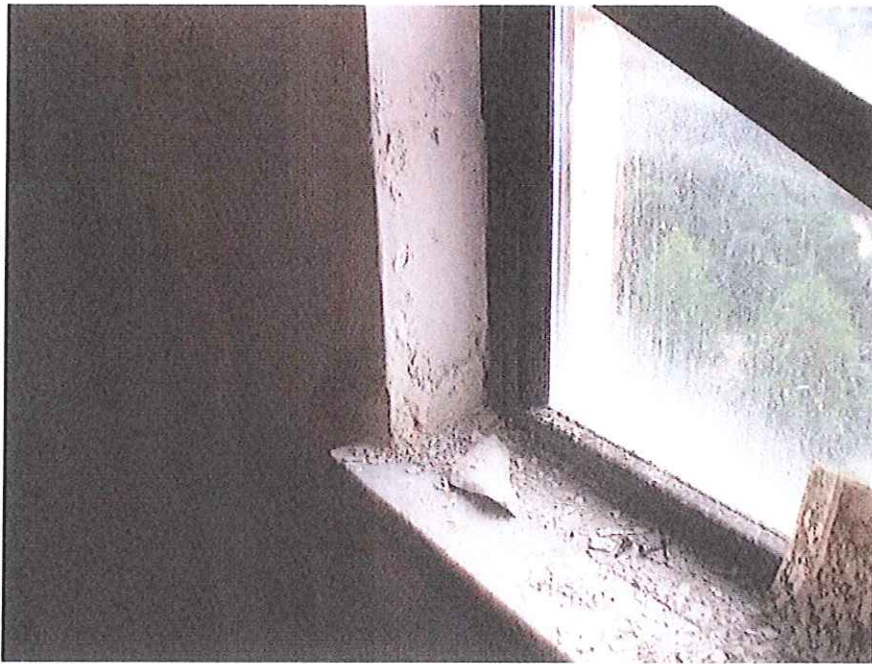
65. A view of the damaged interior finishes on the eighth floor at the southeast corner of the building.

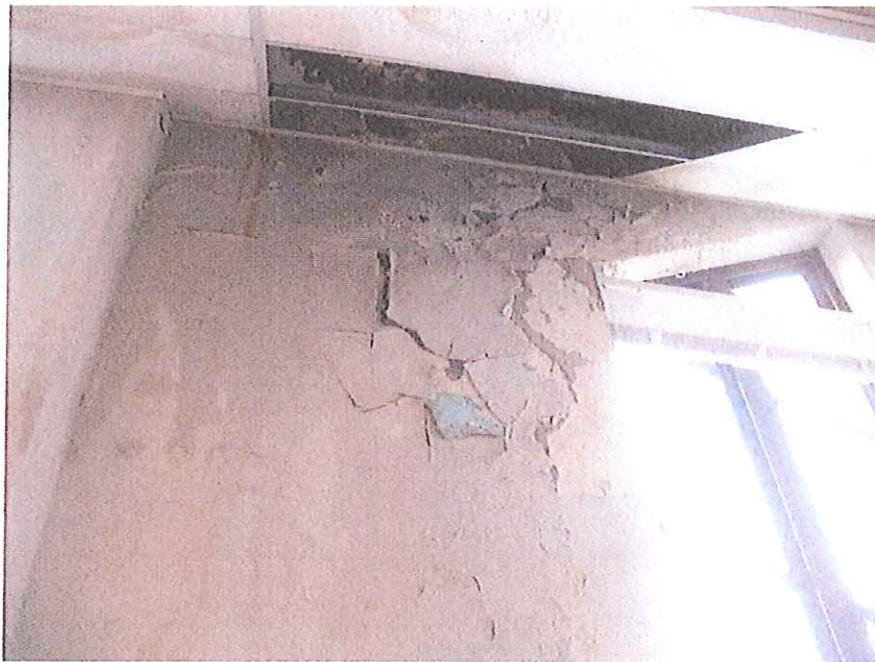
66. Some of the damage present due to water intrusion at the eighth floor level.
